# VEHICLE INSPECTION REPORT

**PF70CBV**

## Mercedes-Benz Sprinter 315 CDI PROGRESSIVE

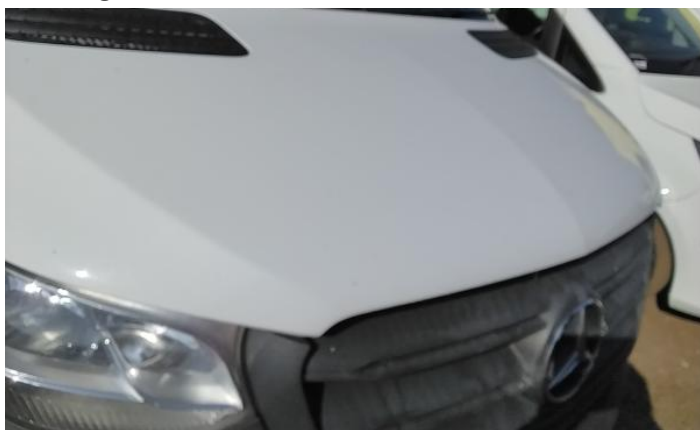
1: Bonnet  
Chipped  
Multiple Chips

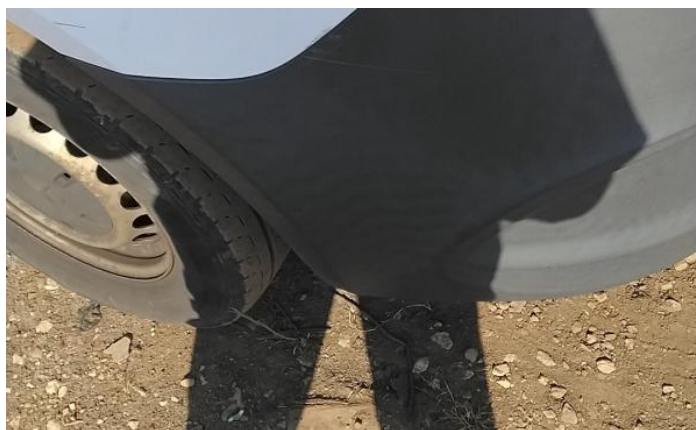
2: Bumper Front  
Scratched  
Over 100mm Thru Paint

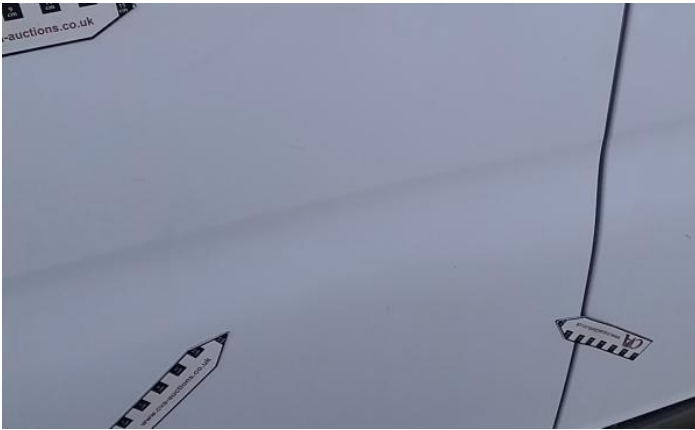
3: Qtr Panel nsr  
Dented  
Over 30mm

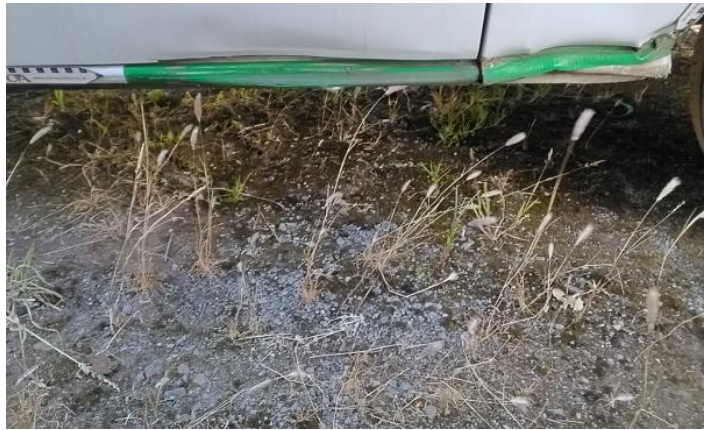
4: Sill ns  
Dented  
With Paint Damage

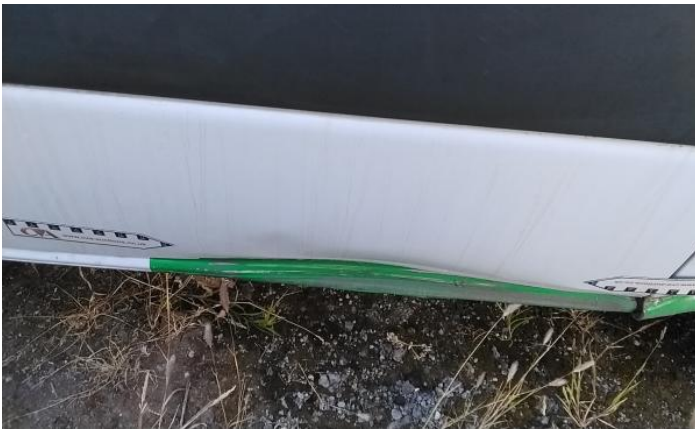
5: Qtr Panel nsr  
Dented  
Over 30mm

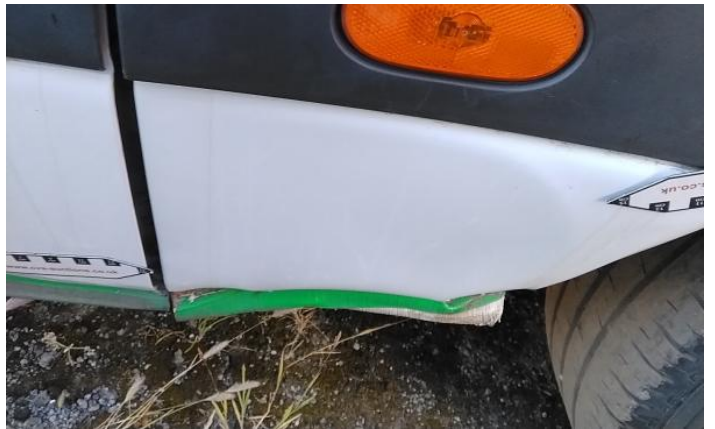
6: Qtr Panel nsr  
Dented  
Over 30mm

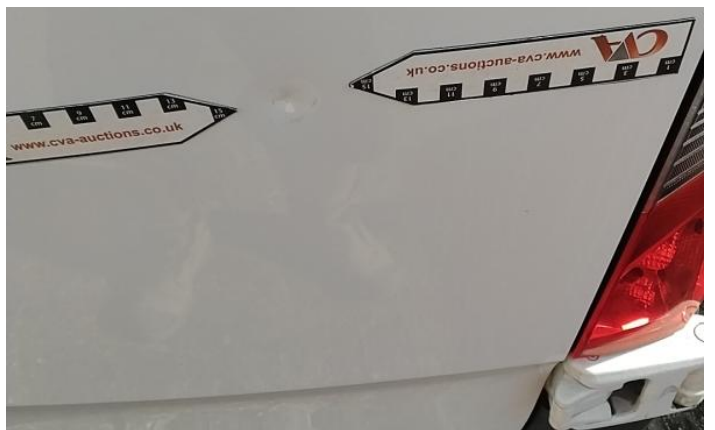
8: Door osr  
Dented  
With Paint Damage

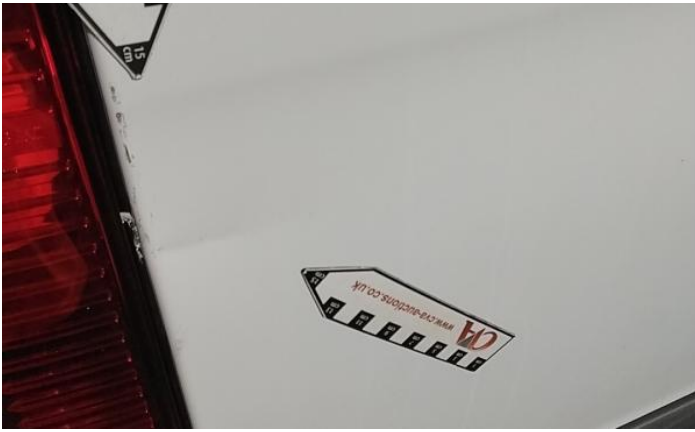
9: Qtr Panel osr  
Dented  
Over 30mm

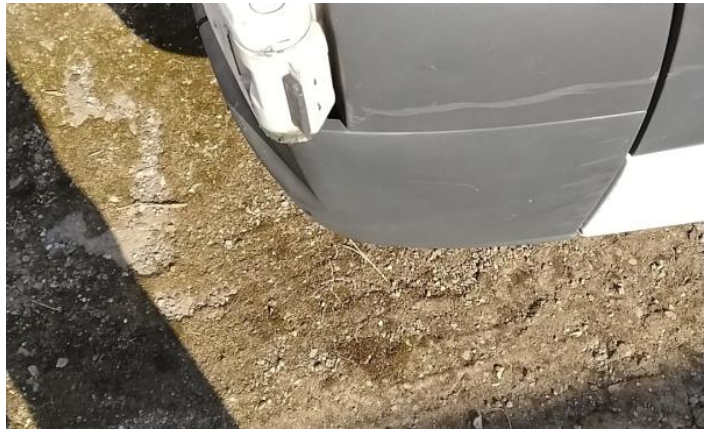
10: Bumper Rear Moulding  
Scuffed (Unpainted)  
Over 100mm

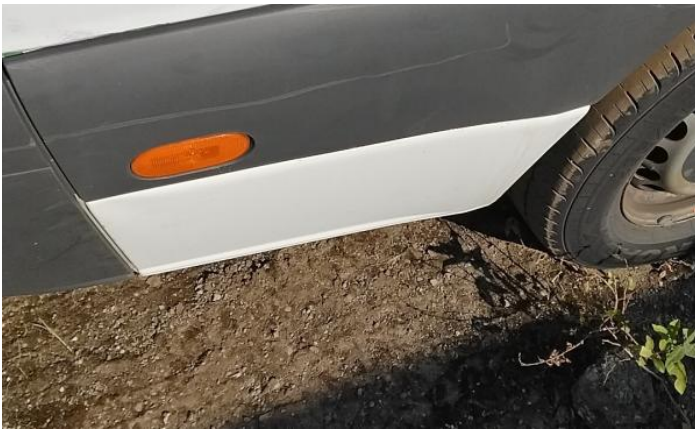
11: Qtr Panel Moulding os  
Scuffed (Unpainted)  
Over 100mm

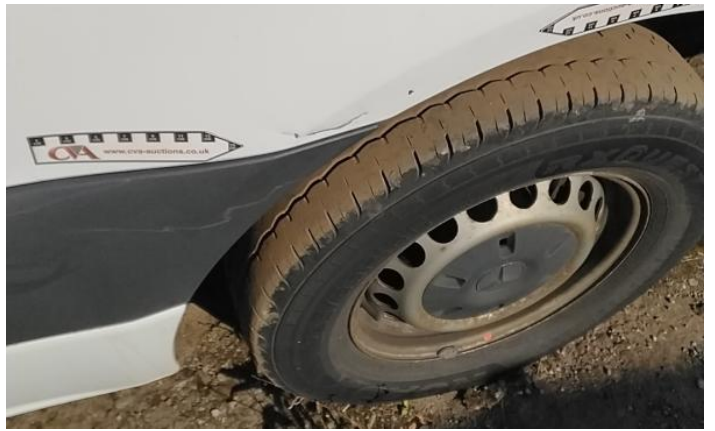
12: Qtr Panel osr  
Dented  
With Paint Damage

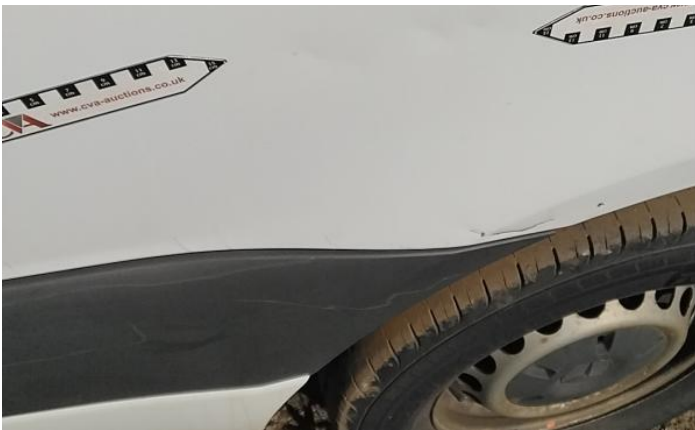
13: Qtr Panel osr  
Dented  
Over 30mm

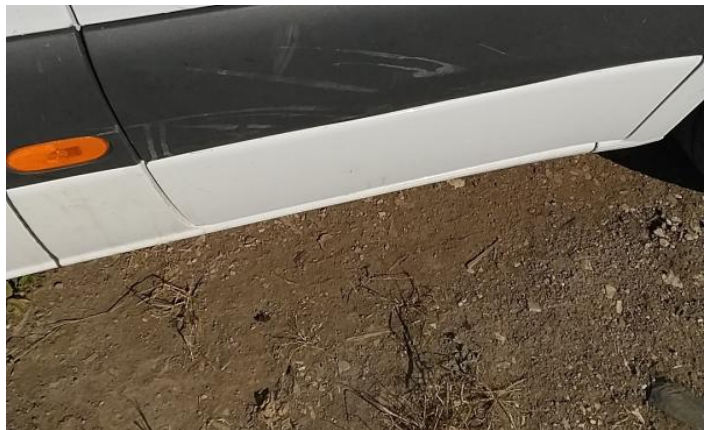
14: Door Moulding osf  
Scuffed (Unpainted)  
Over 100mm

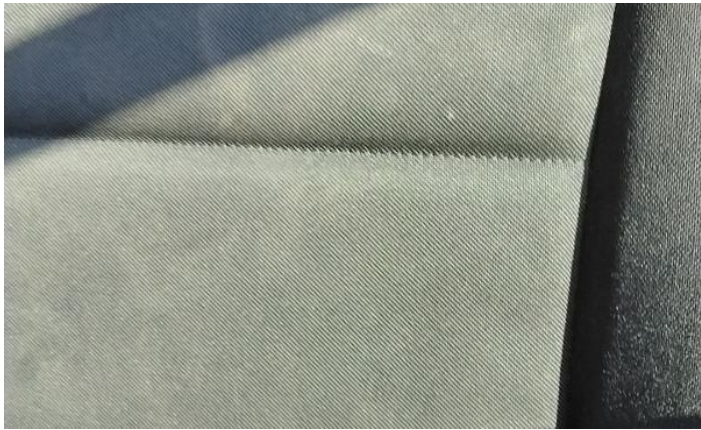
15: Seat Base Cover osf  
Soiled  
Heavy

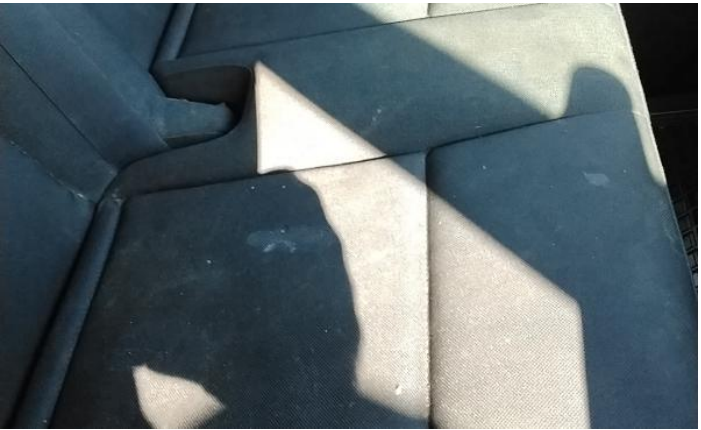
16: Seat Base Cover nsf  
Soiled  
Heavy
